Optoelectronic investigation of the mural paintings from Drăguțești wooden church, Argeș County, Romania

This paper presents the first set of investigations on the mural paintings belonging to Drăguțești wooden church (1813-1814 A.D.) that has recently been included into the patrimony of Golești Museum, Argeș County. Conservation of a religious site of this type requires a deep analysis of materials in order to evaluate correctly the murals' state of conservation, but also for identifying the proper intervention materials that must have characteristics similar to the original ones. Aside from photographic documentation, molecular characterization was achieved via Fourier-transform infrared spectroscopy, while functional analysis was performed with X-ray diffraction and elemental identification was performed with the help of X-ray fluorescence spectroscopy and laser-induced breakdown spectroscopy, aiming to obtain as much information as possible about the mortars and the pigments. The results showed the plasters from the intonaco and arriccio layers are similar, based on lime and quartz sand mortars, correlating with the traditional execution technique. Regarding the pigments used,

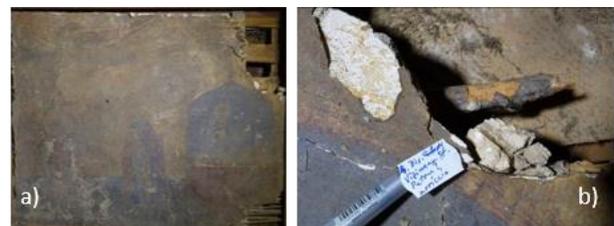
The murals are constructed on a support made from twisted twigs filled with a lime-based plaster rich in aggregates (sand) corresponding to the *arriccio* layer. The murals (Figs. 1-2) are covered with thick adherent deposits layers and present a firm salt crust that reduce the visibility of the iconographic image.

Fig. 1. a) Saint Peter's Vision mural painting, b) D4 sample location.

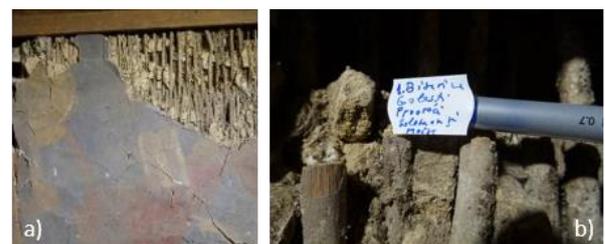
Fig. 2. a) Solomon and Moses mural painting, b) D1 samples' location

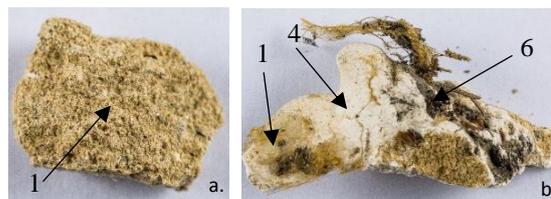
Fig. 3. LIBS areas of investigation on sample D1 from Solomon and Moses mural painting: a. *arriccio* layer, b. white layer

The LIBS analysis on the mortar fragment D1a corresponding to the *arriccio* layer was conducted on two spots of interest, one on each side. The LIBS analysis on the mortar fragment D1b corresponding to the white layer was conducted on 8 spots of interest, but the results were similar and only four were chosen as representative (see Figure 3). In Figure 4 two FTIR spectra are presented, characteristic for two distinct areas of the sample: resin and white basis. The chemical elements and molecules identified by LIBS, XRF and FTIR are described in Table 2.

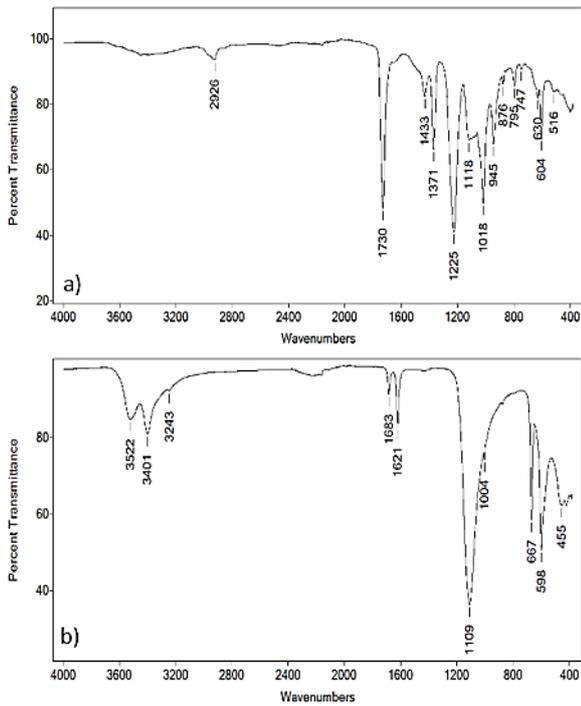
Fig. 4. FTIR spectrum for D1b sample: a) PVA resin and b) white basis (gypsum)

FTIR data obtained on the pigmented layers highlighted strong contributions ascribed to gypsum (calcium sulphate dehydrate): characteristic bands at 3533, 3402, 1620, 1110, 673 and 601 cm^{-1} . The presence of gypsum can be linked to the ground layer. Although the gypsum can also be identified as a degradation product [13], existing literature [14] frequently mentions the use of gypsum for the preparation layer of 19th century wall paintings executed *a secco*.

In terms of organic compounds, the presence of a polyvinyl acetate (PVA) resin was identified on all investigated pigmented areas, via the strong and sharp bands centred at approx. 1730, 1373, 1225, 1017 and 947 cm^{-1} . This synthetic resin, discovered in 1912 [15] can be linked to past restorations, polyvinyl acetate being used in the conservation of wall paintings before 1935, especially as a consolidant for the transfer of wall paintings to new supports [16].

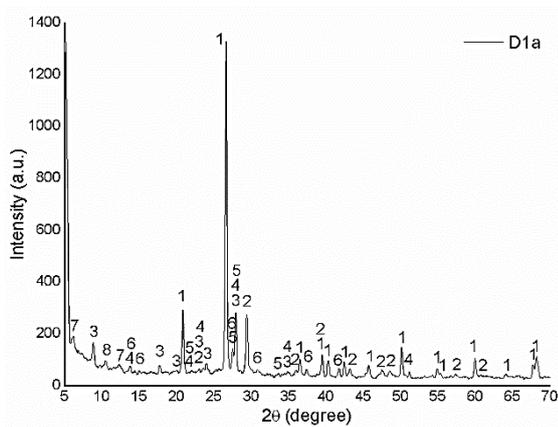
The XRD analysis of sample D1a identified the following mineralogical compounds of the *arriccio* layer: quartz, calcite, muscovite, albite, anorthite, feldspar, clinocllore, ferrohornblende (see Fig. 5).

Fig. 5. X-Ray pattern of the sample D1a: 1 – quartz; 2 – calcite; 3 – muscovite; 4 – albite; 5 – anorthite; 6 – feldspar potassian; 7 – clinocllore; 8 – ferrohornblende

X-ray diffraction (XRD) analysis highlighted the fact that the *intonaco* and *arriccio* layers have similar mineralogical composition, being based on lime:

In all samples, quartz is the major component, the intensity of the specific main line ($2\theta=26,64^\circ$) being 1331 a.u. (D1), 1140 a.u. (D3), 942 a.u. (D4). This can imply that the mortars from which the *intonaco* and *arriccio* layers had been made are richer in aggregate and have less binder. Also, the higher intensity of the lines specific for quartz in sample D1 (*arriccio*) as compared to samples D3 and D4 (*intonaco*), can suggest that D1 contains a higher aggregate amount, which correlates with the proportions used by traditional craftsmen for the manufacturing of the *arriccio* and *intonaco* layers. The intensities of the lines specific for the other components in the aggregate are smaller as compared to those of quartz, which is an indicator of the fact that aggregate is quartz sand.

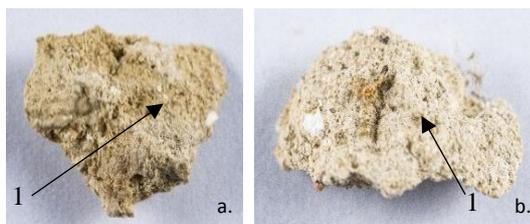
Fig. 6. LIBS spots on the front of the mortar samples from Saint Peter's Vision mural painting: a. D4, b. D5

The LIBS analyses for samples D4 and D5 were conducted on 2 spots of interest for each: 1 on the front side and 1 on the back side of the piece. The LIBS spots of investigation on the front of the samples are depicted in Fig. 6. A combined representative LIBS spectrum of the two samples is presented in Fig. 7 and the XRF spectrum obtained for the D5 sample is depicted in Fig. 8. The chemical elements and molecules identified using LIBS, XRF and FTIR are described in Table 2.

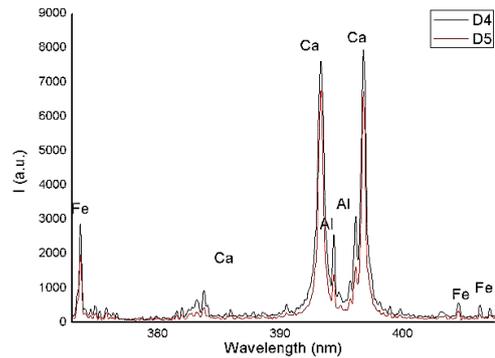
Fig. 7. LIBS spectrum for: D4 (red) and D5 (blue) samples

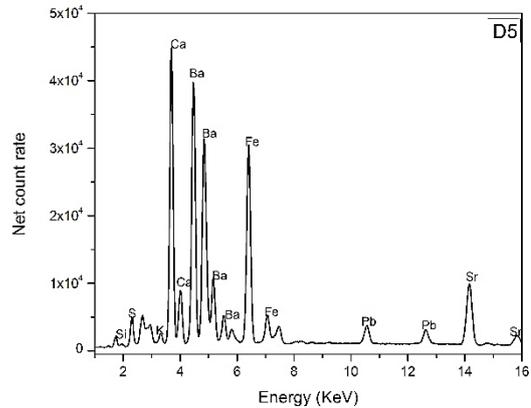
Fig. 8. XRF spectrum for D5 sample

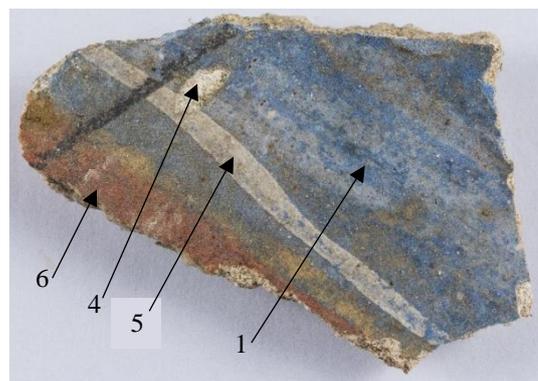
Fig. 9. LIBS areas of investigation on sample D3 from Solomon and Moses mural painting

LIBS analysis on sample D3 was conducted on 9 spots of interest: 7 on the front side and 2 on the back side of the piece. The position of the LIBS spots of investigation is depicted in Fig. 9. A representative LIBS spectrum is presented in Fig. 10 and the XRF spectrum obtained for the D3 sample is depicted in Fig. 11. The chemical elements and compounds are described in Table 2.

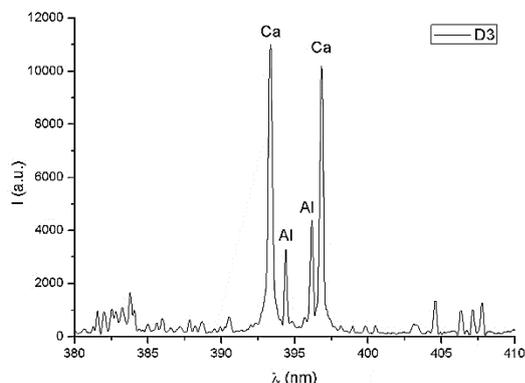
Fig. 10. LIBS spectrum for D3 sample

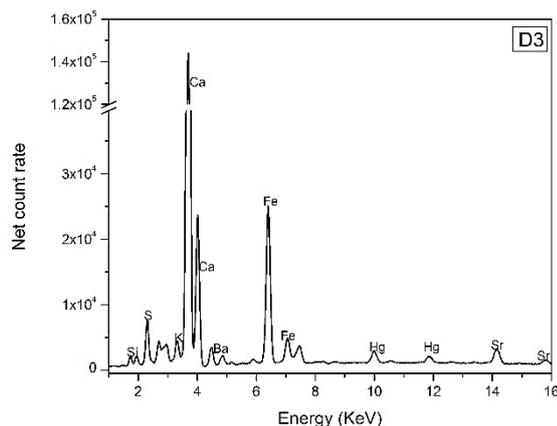
Fig. 11. XRF spectrum for D3 red pigment

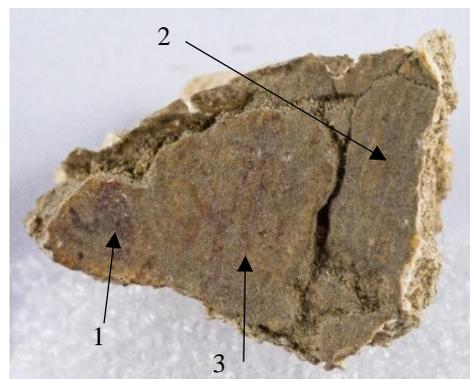
Fig. 12. LIBS areas of investigation on sample D6 from Saint Peter's Vision mural painting

LIBS analysis on sample D6 was conducted on 10 spots of interest: 3 on the front side, 3 on the rear side and 4 on the cross-section parts. The position of some of the LIBS spots of investigation is depicted in Figure 12. The results obtained on the cross-section are similar to the ones obtained for the front and the rear areas, therefore the discussions will consider only 6 points of interest. The chemical elements and compounds that have been identified using the LIBS, XRF and FTIR techniques are described in Table 2.
